**Flood Control Project Maintenance
Levee Inspections**
LMA District Cover Sheet
Spring 2018 Levee Inspection Results

Sacramento Maintenance Yard Sacramento Bypass

Levee Inspection Report By Mile - Spring 2018

Waterway	Bank	Unit Miles	Inspection Start/End	Inspector
Unit No. 01 Sacramento Bypass or North Levee	Right	1.74	04/17/2018 04/17/2018	Zach Jojola

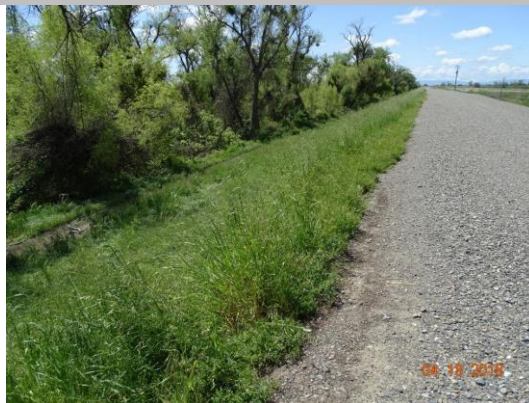
Photo 1 of 1 : SP_2018_ST0008_284_7_20180419_00021.jpg

LM Start	0.40	Rating **	U	Issue No.	7
LM End	1.73	Issue Type +	Ma	Location *	WS
Category	Earthen Levee			GPS Latitude/Longitude	
				Start	End
Item	Vegetation			38.605010 °	38.599469 °
				-121.566808 °	-121.590155 °
DWR ID	DWR_ST0008_01_s_2018_7				
Comment Code					
V1 : Control annual grass and weeds on the levee slopes and easements.					
Inspector Comment

View of vegetation on the waterside slope. Spring 2018.

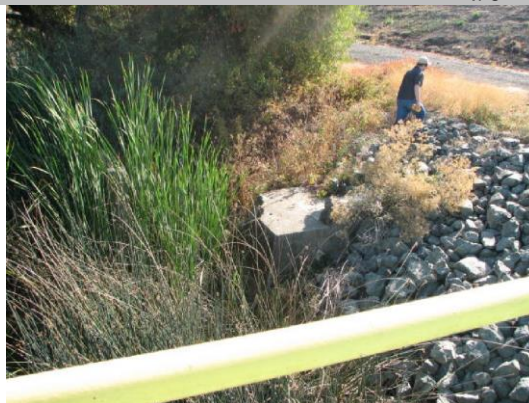
Photo 1 of 3 : UCIP_SP_2018_44787_20605.jpg

LM Start	1.09	Rating **	A/W	Issue No.	16	
LM End	1.09	Issue Type +	Ma	Location *		
Category	Supplemental			GPS Latitude/Longitude		
				Start	End	
Item	DWR UCIP LMA Responsibility			38.602169°	38.602169°	
				-121.579000°	-121.579000°	
DWR ID						
Comment Code						
Inspector Comment						
FS_ID:44787 DS_ID:19076 EP_NO: N/A Repair Type: No Action Needed Crossing Status: Found UCIP Comments: A concrete saddle found on slough/drainage. No pump was found on LS and no structure/pipe found on WS. FIELD_STRUCT_DESC: *ABANDONED* 36-inch corrugated metal drainage pipe through the levee, at an unknown depth. Grouted in place. Remains of concrete structure found on the landside (LS). [Additional Reference(s): USACE Sacramento O&M Manual 122.1, August 1955, (RM 174)]. FS Date: 4/28/2015 2:44:05 PM

Landside view: overview

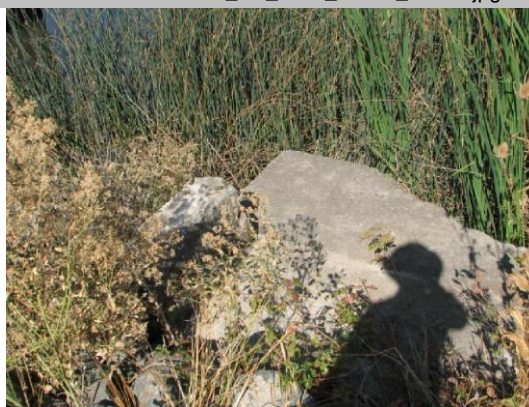
Photo 2 of 3 : UCIP_SP_2018_44787_20604.jpg

Landside view: remaining of concrete structure

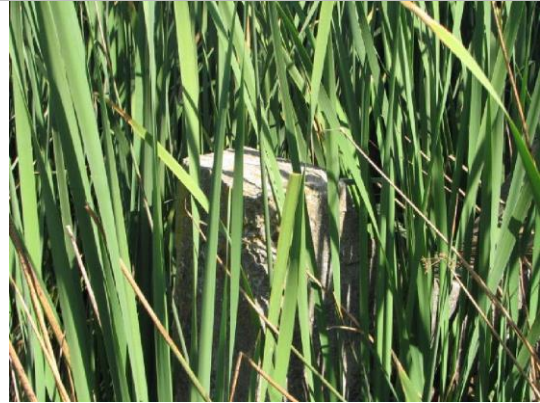
Photo 3 of 3 : UCIP_SP_2018_44787_20606.jpg

Landside view: remaining of concrete structure on drainage/slough

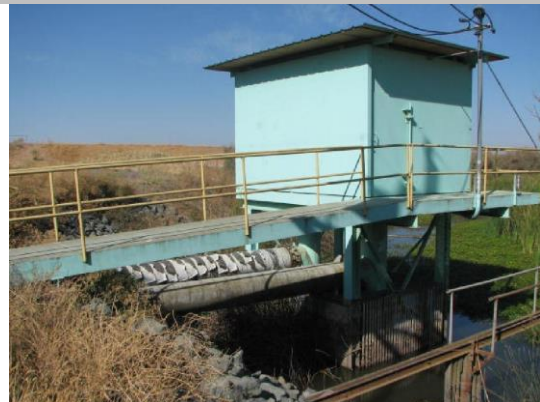
Photo 1 of 3 : UCIP_SP_2018_44783_20611.jpg

Comment Code					
Inspector Comment					
FS_ID:44783 DS_ID:19066 EP_NO: 13616 Repair Type: Non-Urgent Crossing Status: Found UCIP Comments: After more investigation depressions are from water run off. erosion repair needed FIELD_STRUCT_DESC: [Agricultural Drainage Pumping System] 1 of 2: 24-inch concrete encased steel discharge pipeline through the right bank (north) levee of the Sacramento Bypass, 6.33 feet below the crown. Siphon breaker on the waterside (WS). Vertical galvanized iron pipe trash rack on the inlet structure. (24-inch pipeline authorized under Permit No. 13616, 1995 - Reclamation District No. 537 [revised]). FS Date: 4/28/2015 2:43:01 PM

Landside view: pumping plant overview

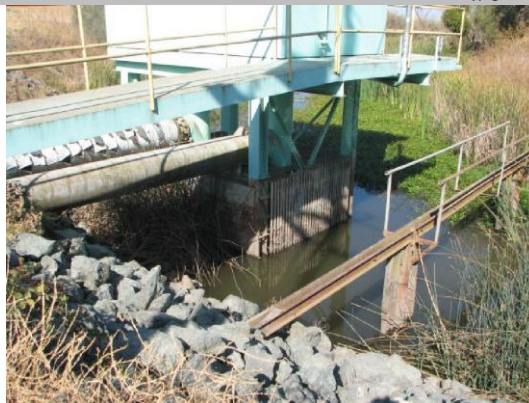
Photo 2 of 3 : UCIP_SP_2018_44783_20609.jpg

Comment Code						
Inspector Comment						
FS_ID:44783 DS_ID:19066 EP_NO: 13616 Repair Type: Non-Urgent Crossing Status: Found UCIP Comments: After more investigation depressions are from water run off. erosion repair needed FIELD_STRUCT_DESC: [Agricultural Drainage Pumping System] 1 of 2: 24-inch concrete encased steel discharge pipeline through the right bank (north) levee of the Sacramento Bypass, 6.33 feet below the crown. Siphon breaker on the waterside (WS). Vertical galvanized iron pipe trash rack on the inlet structure. (24-inch pipeline authorized under Permit No. 13616, 1995 - Reclamation District No. 537 [revised]). FS Date: 4/28/2015 2:43:01 PM

Landside view: vertical GI pipes in inlet structure.

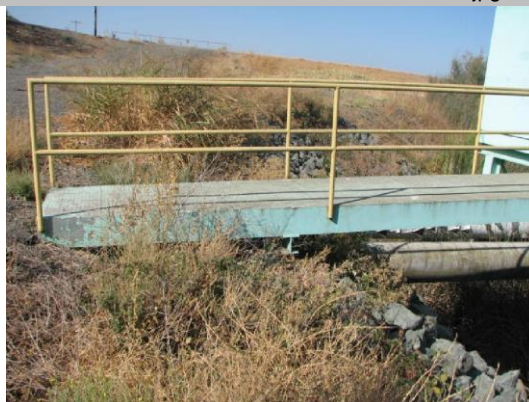
Photo 3 of 3 : UCIP_SP_2018_44783_20608.jpg

Landside view: walkway to the pump house.

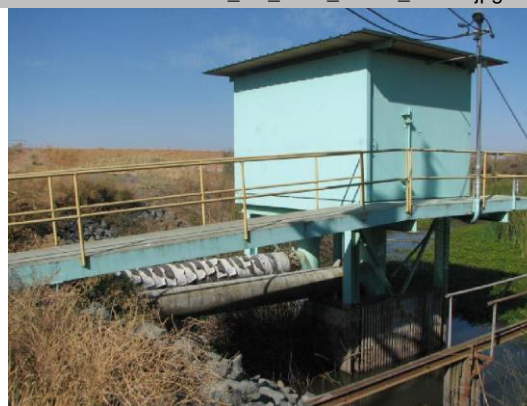
Photo 1 of 3 : UCIP_SP_2018_44784_20619.jpg

Comment Code					
Inspector Comment					
FS_ID:44784 DS_ID:19079 EP_NO: 13616 Repair Type: Non-Urgent Crossing Status: Found UCIP Comments: Horizontal Air vent on waterside slope. Green vegetation and depressions also found on waterside slope. FIELD_STRUCT_DESC: [Agricultural Drainage Pumping System] 2 of 2: 20-inch concrete encased steel discharge pipeline through the right bank (north) levee of the Sacramento Bypass, 6.33 feet below the crown. Siphon breaker on the waterside (WS). Vertical galvanized iron pipe trash rack on the inlet structure. (24-inch pipeline authorized under Permit No. 13616, 1995 - Reclamation District No. 537 [revised]). FS Date: 4/28/2015 2:43:26 PM

Landside view: overview of pumping plant

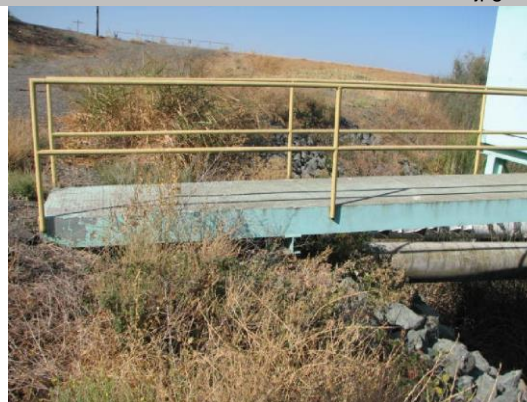
Photo 2 of 3 : UCIP_SP_2018_44784_20618.jpg

Landside view: walkway to the pumping plant

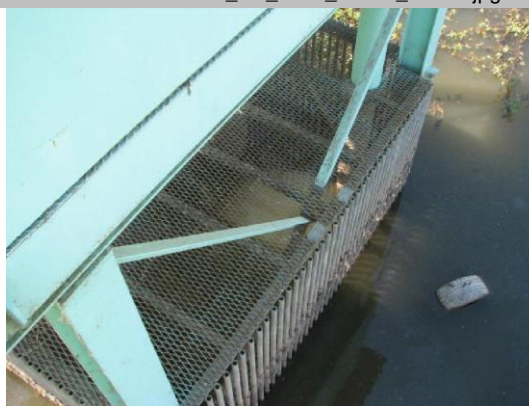
Photo 3 of 3 : UCIP_SP_2018_44784_20617.jpg

Comment Code						
Inspector Comment						
FS_ID:44784 DS_ID:19079 EP_NO: 13616 Repair Type: Non-Urgent Crossing Status: Found UCIP Comments: Horizontal Air vent on waterside slope. Green vegetation and depressions also found on waterside slope. FIELD_STRUCT_DESC: [Agricultural Drainage Pumping System] 2 of 2: 20-inch concrete encased steel discharge pipeline through the right bank (north) levee of the Sacramento Bypass, 6.33 feet below the crown. Siphon breaker on the waterside (WS). Vertical galvanized iron pipe trash rack on the inlet structure. (24-inch pipeline authorized under Permit No. 13616, 1995 - Reclamation District No. 537 [revised]). FS Date: 4/28/2015 2:43:26 PM

Landside view: vertical GI pipe trash rack in inlet structure.

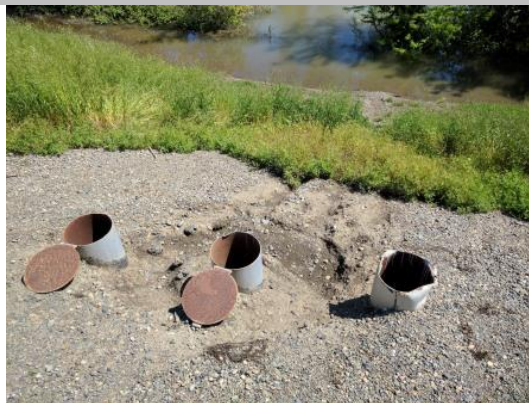
Photo 1 of 1 : SP_2018_ST0008_284_14_20180306_00010.jpg

LM Start	1.29	Rating **	M	Issue No.	14
LM End	1.29	Issue Type +	En	Location *	WS
Category	Earthen Levee			GPS Latitude/Longitude	
				Start	End
Item	Encroachments			38.601246 °	38.601246 °
				-121.582469 °	-121.582469 °
DWR ID	DWR_ST0008_01_s_2017_14				
Comment Code					
PI : Pipe					
Inspector Comment					
Erosion on WS slope from siphon breaker water.

View of erosion on waterside levee slope. Spring 2017.

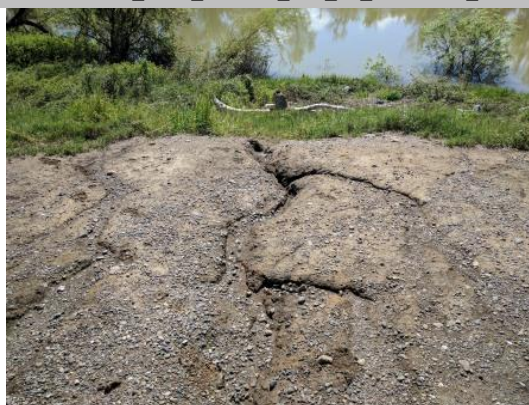
Photo 1 of 1 : SP_2018_ST0008_284_15_20180306_00011.jpg

LM Start	1.74	Rating **	A/W	Issue No.	15
LM End	1.74	Issue Type +	Ma	Location *	WS
Category	Earthen Levee			GPS Latitude/Longitude	
				Start	End
Item	Erosion / Bank Caving			38.599546 °	38.599546 °
				-121.590235 °	-121.590235 °
DWR ID	DWR_ST0008_01_s_2018_15				
Comment Code					
E1 : Note and monitor erosion site.					
Inspector Comment					
Runoff erosion on oversized levee section. Lcoated on waterside levee slope. Recommend monitoring.

View of erosion on waterside slope. Spring 2017.

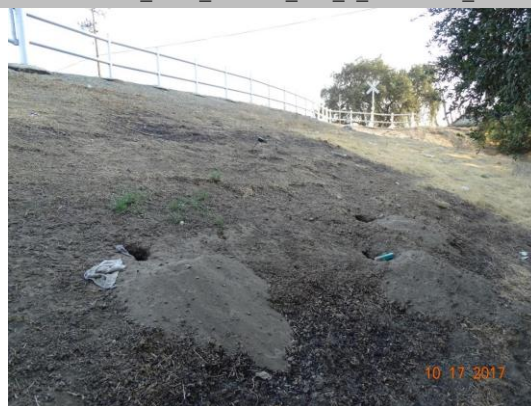
Photo 1 of 2 : SP_2018_ST0008_285_2_20180306_00004.jpg

LM Start	0.03	Rating **	M	Issue No.	2
LM End	0.03	Issue Type +	Ma	Location *	LS
Category	Earthen Levee			GPS Latitude/Longitude	
				Start	End
Item	Animal Control			38.602613 °	38.602613 °
				-121.556021 °	-121.556021 °
DWR ID	DWR_ST0008_02_s_2016_2				
Comment Code					
A3 : No rodents visible, but rodent burrows visible; need to backfill and compact or grout burrows.					
Inspector Comment

Updated view of rodent holes on landside slope. Fall 2017.

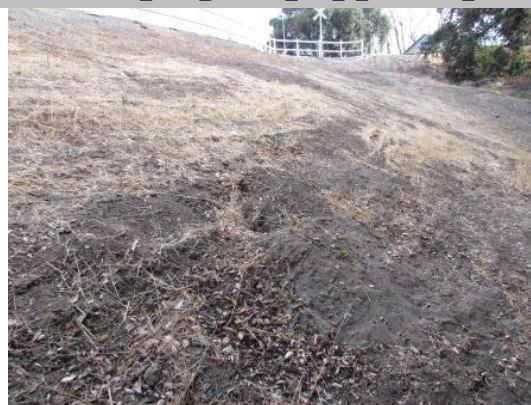
Photo 2 of 2 : SP_2018_ST0008_285_2_20180306_00005.jpg

View of rodent holes on LS slope of the levee near entry gate. Fall 2016..

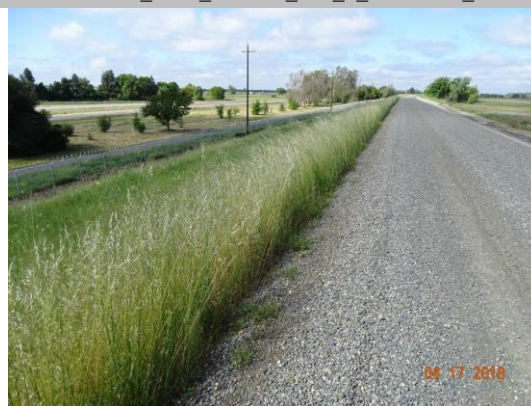
Photo 1 of 1 : SP_2018_ST0008_285_9_20180419_00013.jpg

LM Start	0.03	Rating **	U	Issue No.	9
LM End	1.77	Issue Type +	Ma	Location *	LS
Category	Earthen Levee			GPS Latitude/Longitude	
				Start	End
Item	Vegetation			38.602599 °	38.594798 °
				-121.556036 °	-121.586466 °
DWR ID	DWR_ST0008_02_s_2018_9				
Comment Code					
V1 : Control annual grass and weeds on the levee slopes and easements.					
Inspector Comment

View of vegetation on the landside slope. Spring 2018.

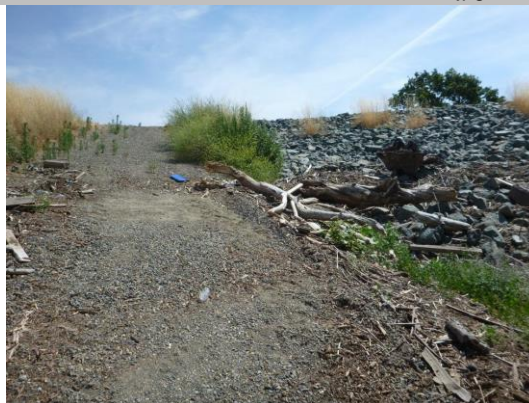
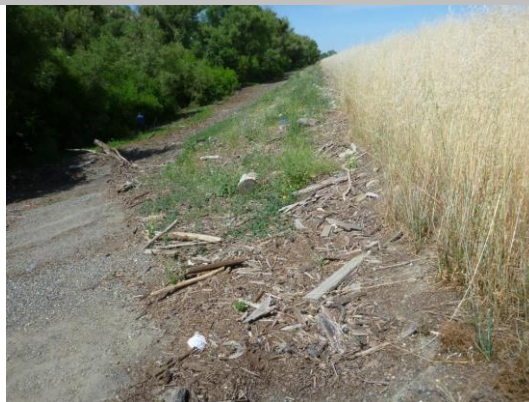
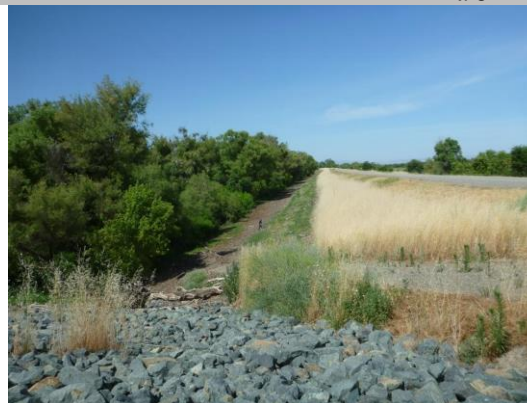
LM Start	1.26	Rating **	A/W	Issue No.	1
LM End	1.79	Issue Type +	Ma	Location *	
Category	Supplemental			GPS Latitude/Longitude	
				Start	End
Item	2017 Storm Damage			38.597023 °	38.594527 °
				-121.577558 °	-121.586638 °
DWR ID	DWR_ST0008_02 f _ 2017_1

Repair Type: Erosion

Notes: Minor wavewash on landside levee slope; no active erosion; no cross section taken, photo only. No visible damage observed during fall inspection.

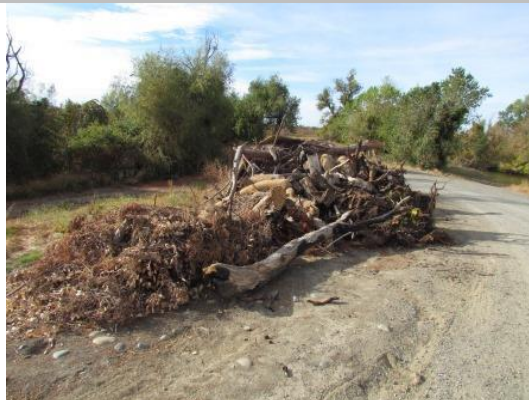
Photo 1 of 2 : SP_2018_ST0008_285_5_20180306_00009.jpg

LM Start	1.77	Rating **	A/W	Issue No.	5
LM End	1.77	Issue Type +	Ma	Location *	LS
Category	Earthen Levee			GPS Latitude/Longitude	
				Start	End
Item	Encroachments			38.594743 °	38.594743 °
				-121.586556 °	-121.586556 °
DWR ID	DWR_ST0008_02_s_2016_5				
Comment Code					
PR : Prunings					
Inspector Comment					
This is a seasonal pile but gets burned by the LMA each year.

More debris was added to the pile since the time of last inspection. Fall 2016.

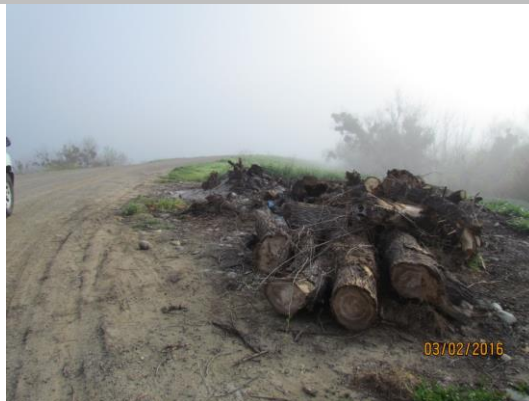
Photo 2 of 2 : SP_2018_ST0008_285_5_20180306_00010.jpg

View of the firewood on the landward side of the levee looking upstream. Spring 2016.

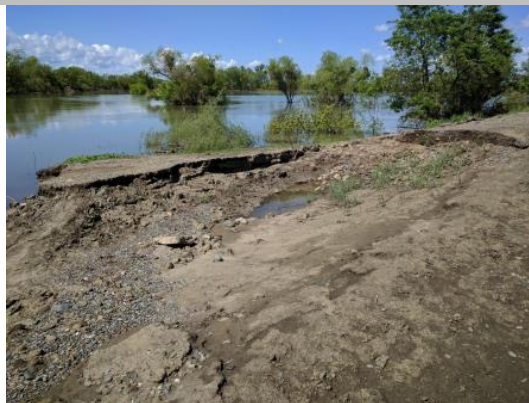
Photo 1 of 1 : SP_2018_ST0008_285_8_20180306_00012.jpg

LM Start	1.77	Rating **	A/W	Issue No.	8
LM End	1.77	Issue Type +	Ma	Location *	WS
Category	Earthen Levee			GPS Latitude/Longitude	
				Start	End
Item	Erosion / Bank Caving			38.594710 °	38.594710 °
				-121.586582 °	-121.586582 °
DWR ID	DWR_ST0008_02_s_2017_8				
Comment Code					
E1 : Note and monitor erosion site.					
Inspector Comment					
Runoff location, but not within the levee prism. Recommend monitoring.

View of erosion on waterside levee slope. Spring 2017.
